DEPARTMENT OF TRANSPORTATION

Quality Assurance and Source Inspection

Contract #: 04-0120F4Cty: SF/ALA Rte: 80 PM: 13.2/13.9File #: 69.28**WELDING INSPECTION REPORT****Resident Engineer:**Siegenthaler, Peter**Address:** 333 Burma Road**City:** Oakland, CA 94607**Report No:** WIR-021919**Date Inspected:** 03-Mar-2011**Project Name:** SAS Superstructure**OSM Arrival Time:** 700**Prime Contractor:** American Bridge/Fluor Enterprises, a JV**OSM Departure Time:** 1900**Contractor:** Zhenhua Port Machinery Company, Ltd (ZPMC), Changxing Island **Location:** Shanghai, China**CWI Name:** Geng Wei**CWI Present:** Yes No**Inspected CWI report:** Yes No N/A**Rod Oven in Use:** Yes No N/A**Electrode to specification:** Yes No N/A**Weld Procedures Followed:** Yes No N/A**Qualified Welders:** Yes No N/A**Verified Joint Fit-up:** Yes No N/A**Approved Drawings:** Yes No N/A**Approved WPS:** Yes No N/A**Delayed / Cancelled:** Yes No N/A**Bridge No:** 34-0006**Component:** OBG Components**Summary of Items Observed:**

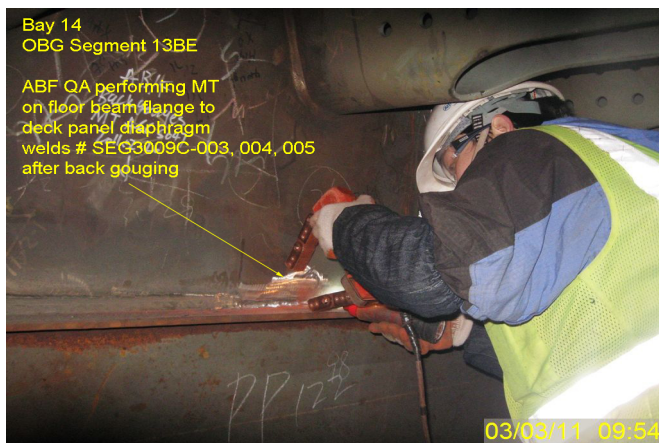
This QA Inspector observed ABF qualified NDT personnel perform Magnetic particle testing (MT) on deck panel diaphragm to deck panel diaphragm weld and deck panel diaphragm to floor beam flange weld on OBG Segment 13BE panel point 122, after back gouging. Weld joints are identified as SEG3009C-003, 004, 005. See attached picture.
